**REPORT ON STRUCTURAL VISUAL  
INSPECTION OF THE BARN  
PROPOSED TO BE REPAIRED AND  
SYMPATHETICALLY CONVERTED  
FOR COMMERCIAL USE**

Falconhurst  
Markbeece  
Edenbridge  
Kent  
TN8 5NR

**REPORT ON STRUCTURAL VISUAL  
INSPECTION OF THE GROOMS  
HOUSE AND THE GARAGE BLOCK  
PROPOSED TO BE REPAIRED AND  
SYMPATHETICALLY CONVERTED  
FOR COMMERCIAL USE**

Falconhurst  
Markbeech  
Edenbridge  
Kent  
TN8 5NR

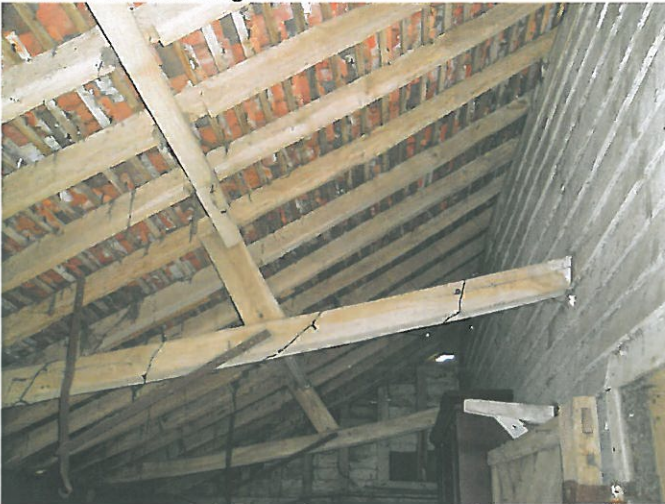
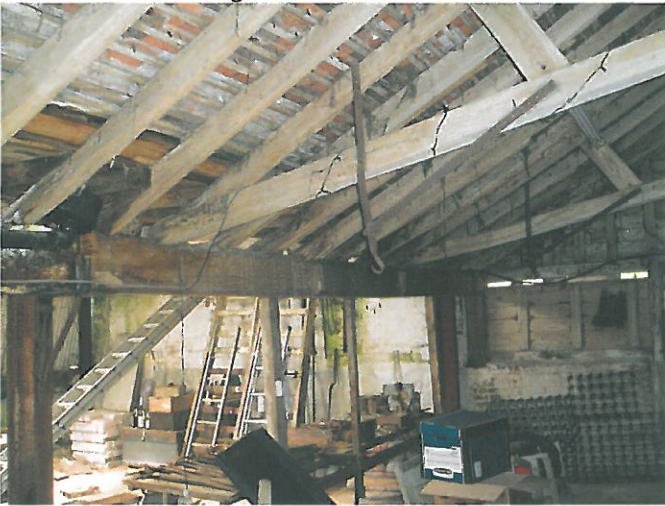
Lean to behind original Barn

A number of timber posts are affected by a degree of rot at low level. A number of posts are out of plumb to a degree. The beam supporting the bottom of the rear lean to rafters and supporting timbers deflects significantly. The steelwork to the cow shed is affected by a degree of corrosion. The steelwork is not braced. The walls to the right hand rear outbuilding are affected by extensive and significant cracking.

- 7.3 Repair / replace the timber weatherboarding as necessary.
- 7.4 The new extension should provide additional support to the outer roof edge of the rear lean to extension directly behind the original 18<sup>th</sup> century barn structure.
- 7.6 The right hand rear brick outbuilding is likely to require underpinning and then repairs using resin repair techniques and incorporating suitable tie bars by 'Helifix' or other similar approved system.

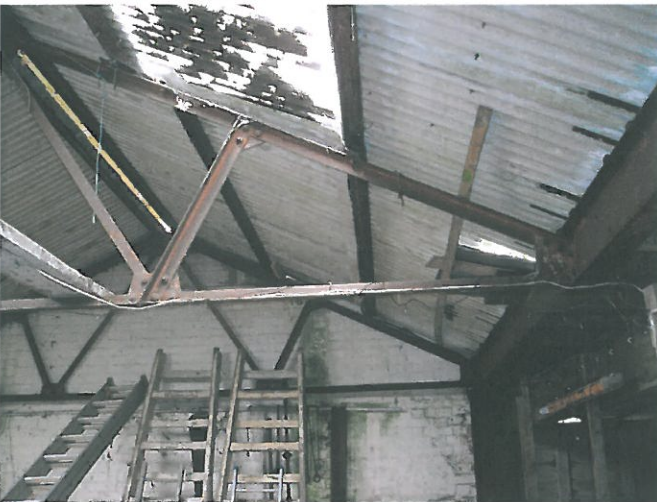
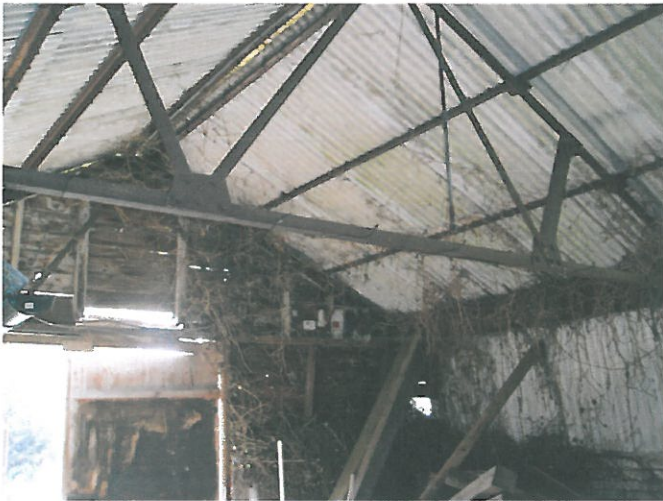
Cow Shed steelwork

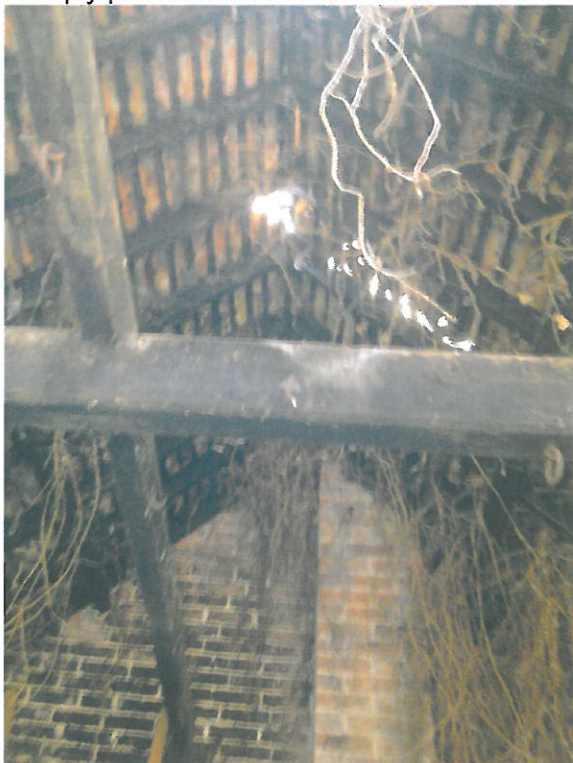
Steeply pitched rafters and central tie to brick outbuilding

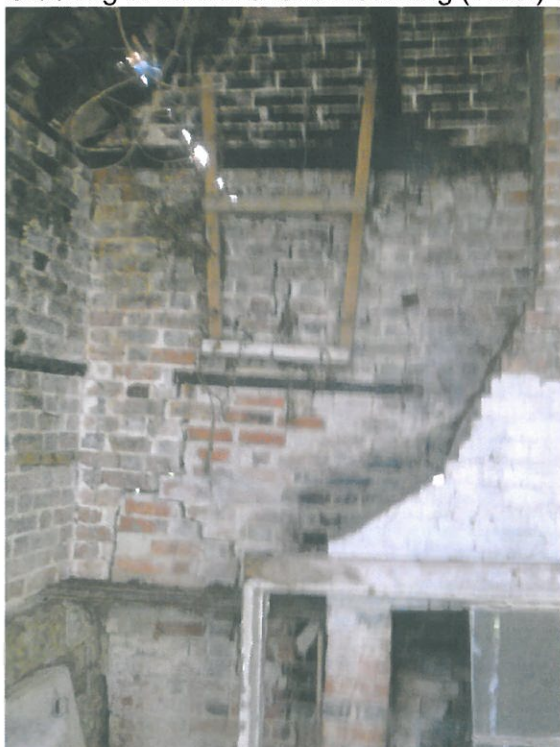
6.3 The right hand rear brick outbuilding is affected by normal differential foundation settlement or possibly by subsidence?

Cracking to wall of brick outbuilding (West) wall

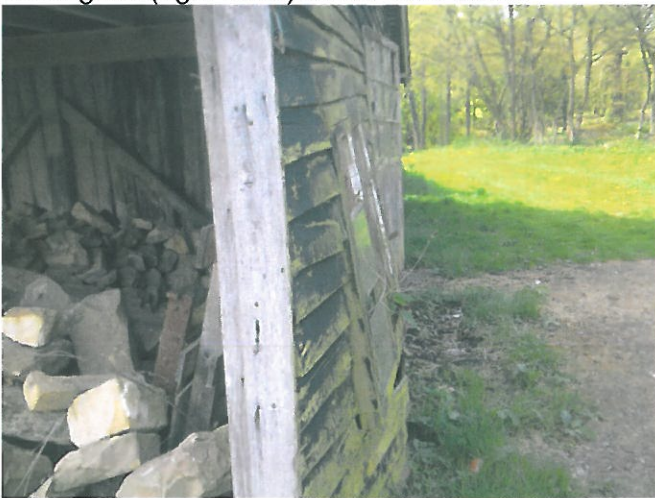
Where the right hand bay of the front section is filled with masonry, this has imposed a lateral load on the right hand flank wall, which has been significantly distorted by this load.

7.2.3 The front right hand corner column and the adjacent timber frame panel to the flank wall have been damaged by the masonry stored in the front right hand bay, which leans against the column and the flank wall.

Damage to (right hand) flank / front corner

8.1.2 Provide propping to support the front eaves beam and to allow repair to the columns and to the right hand flank timber framing panel, removing stored masonry as required.

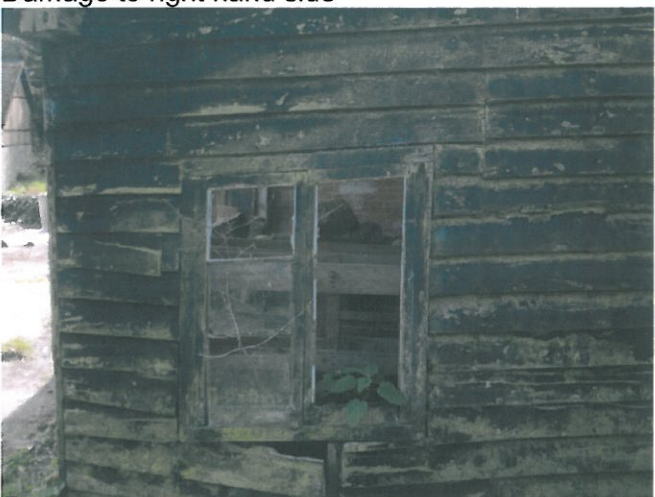
As above, the front timber framed section is significantly damaged by the masonry stored in the building.

Damage to right hand side

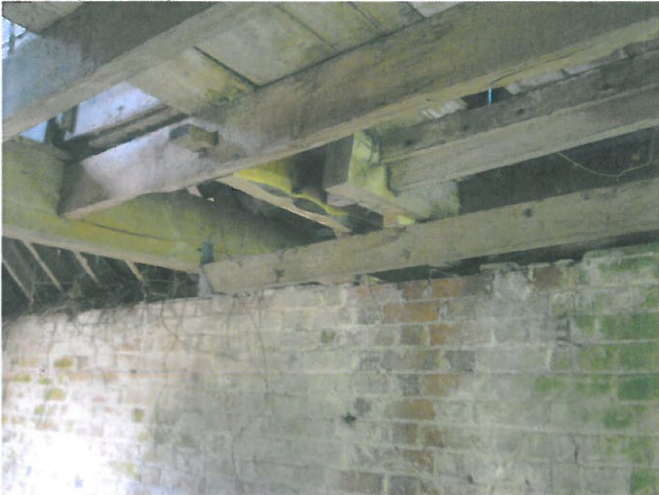
The first floor joist next to the rear wall has dropped significantly at the centre beam support. A temporary repair has been undertaken at this location, which appears to provide support to the dormer support rafters above.

7.2.4 The support provided to the rear roof dormer would appear to be inadequate, causing the ridge line to drop and the rear wall to be pushed outwards. It would also appear that some remedial repairs attempted to improve this support have damaged the first floor joists locally.

Attempted repairs to floor

Undertake strengthening to the rear roof and the first floor to properly support the rear dormer and to stabilise the rear wall.

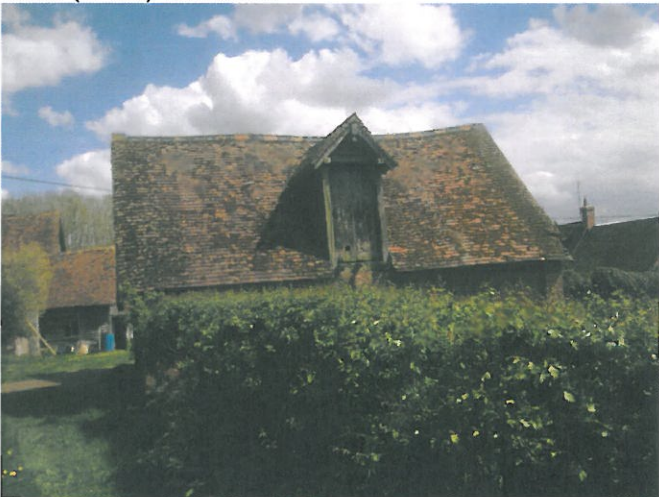
Rear (West) elevation

The ridge line dips significantly to the left hand (South) side. The brickwork has slight cracking and the rear wall appears to lean out to a degree on the left hand side of the building.

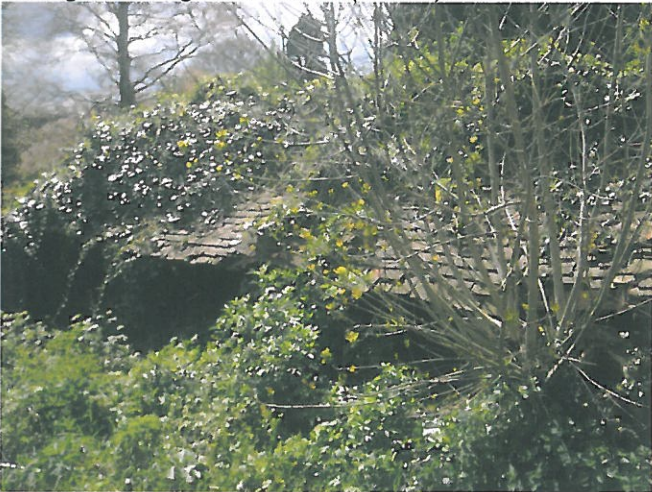
The front roof slope appears to sag excessively. Otherwise, we are unable to comment on the condition of this section of the building, which is almost completely covered with vegetation.

Overgrown vegetation side (South) section

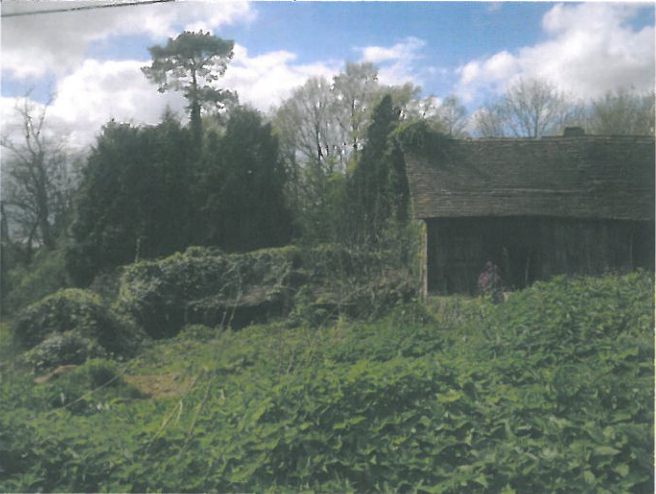
Overgrown side (South) section

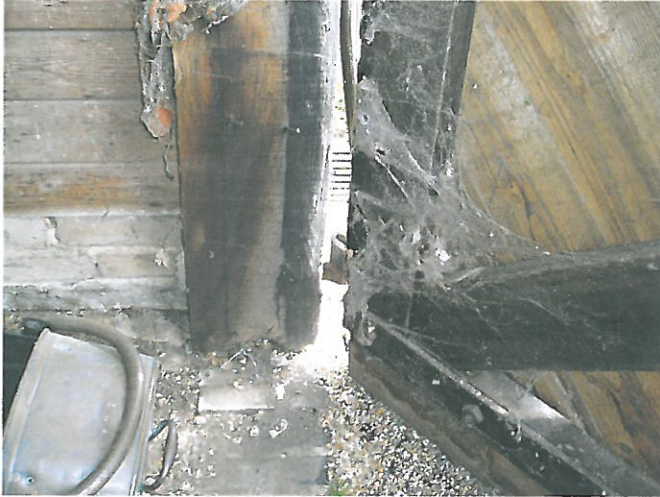
The front posts are affected by rot, where they are seated at ground level and not on the plinth.

The bottom parts of columns in contact with and near to ground level are slightly affected by rot, due to exposure to dampness.

Rot to bottom of post

8.2.1 Provide propping to the front eaves beam to allow repair to the columns.
